## The Muralla Pircada—an ancient Andean debris flow retention dam, Santa Rita B archaeological site, Chao Valley, Northern Perú

**Abstract** Debris flows caused by El Niño events, earthquakes, and glacial releases have affected northern Perú for centuries. The Muralla Pircada, a northeast-trending, 2.5 km long stone wall east of the Santa Rita B archaeological site (Moche-Chimú) in the Chao Valley, is field evidence that ancient Andeans recognized and, more importantly, attempted to mitigate the effects of debris flows. The Muralla is upstream from the site and is perpendicular to local drainages. It is 1–2 m high, up to 5 m wide, and is comprised of intentionally-placed, well-sorted, well-rounded, 20–30 cm cobbles and boulders from nearby streams. Long axes of the stones are gently inclined and parallel local drainage. Case-and-fill construction was used with smaller cobbles and pebbles used as fill. Pre-Muralla debris flows are indicated by meter-sized, angular boulders that were incorporated in-place into construction of the dam and are now exposed in breeches in the dam. Post-Muralla debris flows in the Chao Valley are indicated by meter-sized, angular boulders that now abut

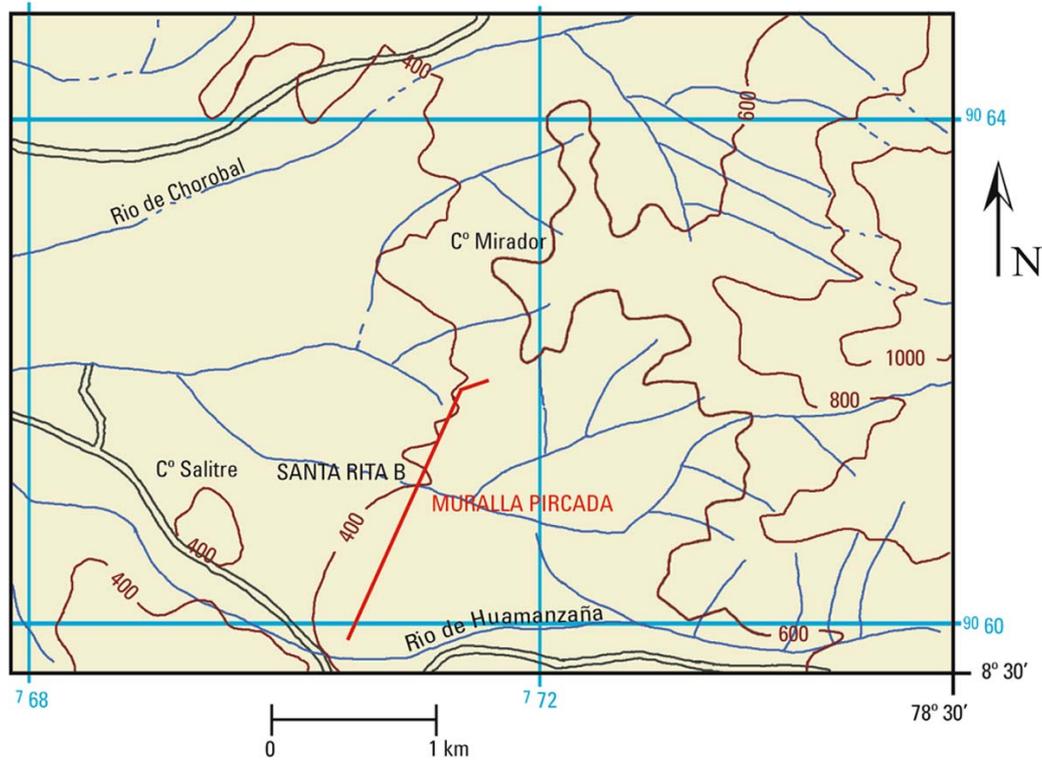
**Fig. 2** Northeast-trending Muralla Pircada with respect to drainages and the Santa Rita B archaeological site (200 m contour interval, base map from Jaen and Vargas 1967)

The Muralla Pircada is a north-northeast-trending, ~2.5 km long stone wall east and up-valley from Santa Rita B (Fig. 2) that is con-

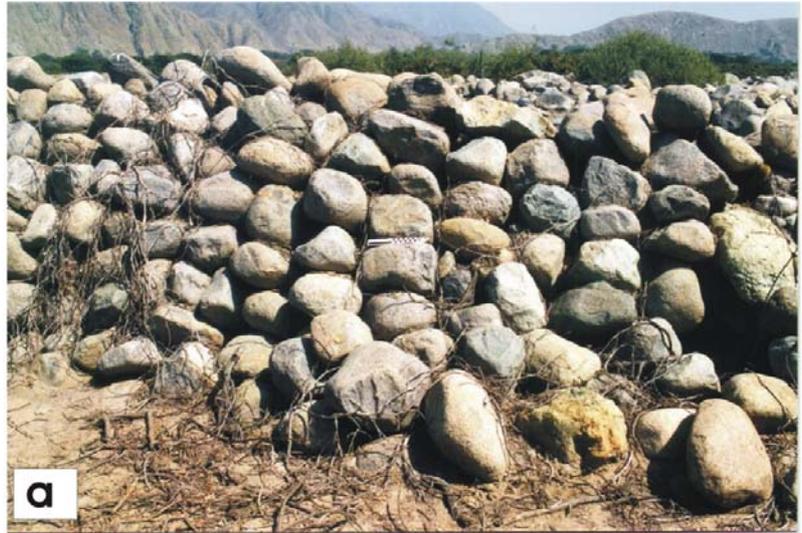
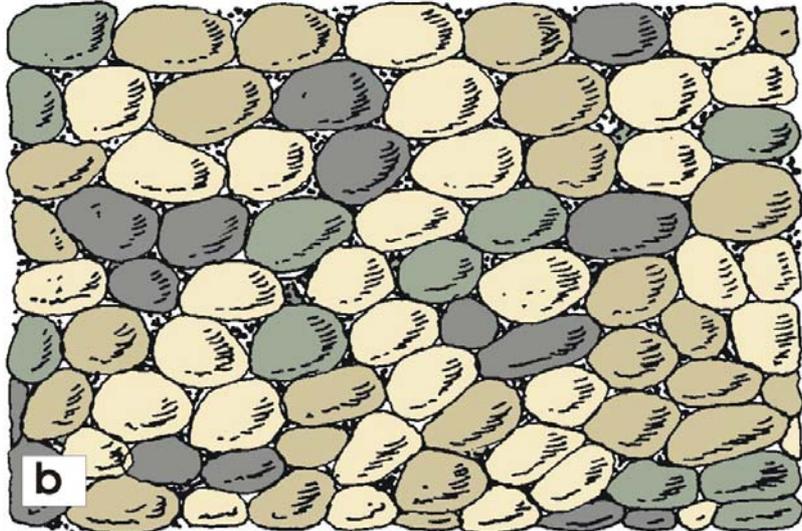
**Fig. 3** **a** Looking west at well-sorted boulders of the Muralla Pircada, Chao Valley, scale is 20 cm. **b** Sketch of rock wall comprised of stream rounded boulders and specifically used for irrigation and protection against erosion caused by running water in northern Perú (from Larco 2001b, aparejo petreo-pirca de canto rodado, pp 213–214, Fig. no. 224)

structed of well-sorted, well-rounded, 20–30 cm and larger (Fig. 3a) volcanic cobbles and boulders. The main part of the Muralla is 1–2 m high and is up to 5 m wide. However, the Muralla turns sharply northeast at about 2.2 km and becomes smaller, less than 1 m high and only 0.8–3.0 m wide.

- Larco (2001b, p. 210) shows a number of specific stone walls used in northern Perú for varied purposes such as irrigation, tombs, and living quarters; most examples show the use of angular cobbles or blocks. However, the construction style for the Muralla Pircada, which uses only stream-rounded cobbles and boulders (Fig. 3a), is strikingly similar to the description by Larco's (2001b), which says "rock wall of rounded stones (Fig. 3b)...used in irrigation canals...frequently found in (irrigation) canals in the Pampas de Chicama and in the Santa, Virú, Chao, and Moche Valleys...found as a simple covering of the walls of the canals to protect against erosion from running water".

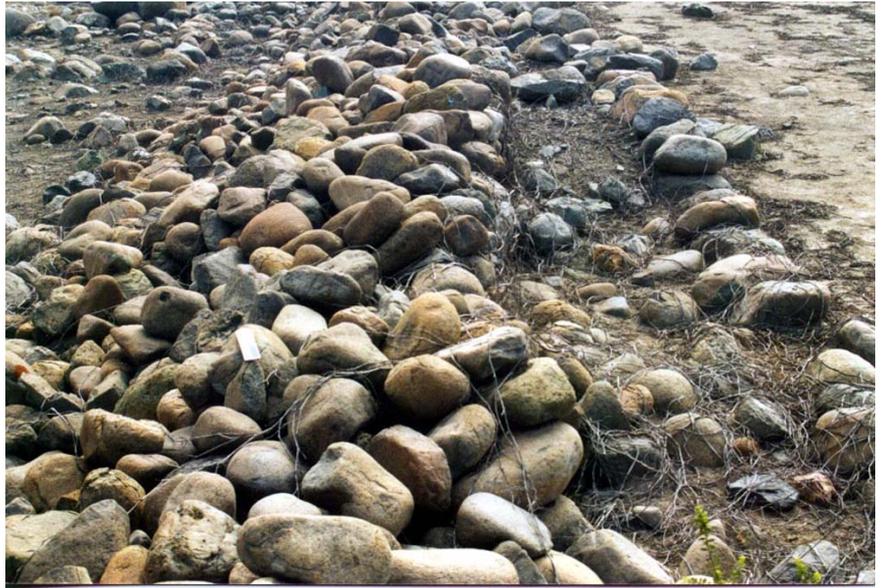
**Fig. 4** Cross-section of the Muralla Pircada showing case-and-fill construction, upstream to the right, approximate width is 4 m, scale is 20 cm

The upstream face of the Muralla is comprised of locally-derived boulders and cobbles that are well-organized and stacked, however, the downstream face is less organized (Fig. 4). Commonly, the long axes of the cobbles and boulders are inclined and perpendicular to the general northeast trend of the structure. And, the long axes of the cobbles and boulders comprising the upstream face of the Muralla are typically parallel with the generally east-west drainage patterns. It is interesting to consider that the pre-Columbian engineers of the Muralla might have attempted to duplicate local stream cobble fabric into construction of the Muralla. These local streams were subjected to periodic torrential currents which would have resulted in orientation of clasts with long axes parallel to stream flow rather than orientation of clasts transverse to stream flow (Pettijohn 1975).

Case-and-fill construction (Fig. 4) was used in wider parts of the Muralla with smaller cobbles and pebbles used as fill. These factors indicate that construction of the Muralla was labor-intensive with a high degree of organization and planning. Additionally, meter-sized angular boulders, exposed in breaches and used in-place for construction, were very likely deposited prior to construction of the Muralla, and are evidence for pre-Muralla mass wasting events in the Chao Valley.

The Muralla Pircada is asymmetrical in cross-section and is thicker, to 5 m, in the downstream direction and tapers to 1 m at the top with a steep, ~70°, upstream face, much like a modern dam. The Muralla

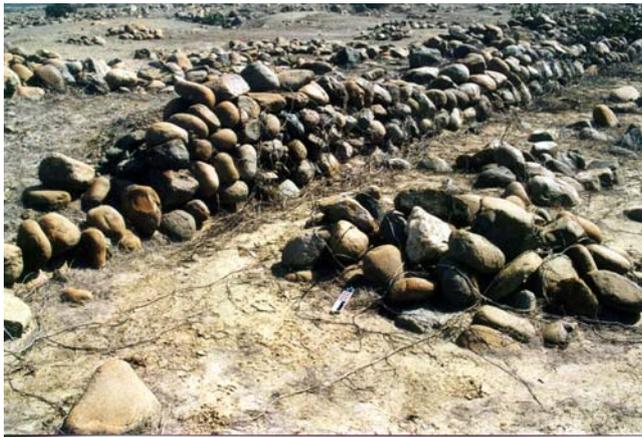
**Fig. 5** Looking downstream at the Muralla Pircada, stockpile of cobbles and boulders in the foreground used for construction or repair, scale is 20 cm

is perpendicular to and crosses the majority of the now abandoned east-west drainages that traverse the site. At several locations on the ground and perpendicular to the Muralla are clusters of 20–30 cm, rounded, and sorted cobbles (Fig. 5). These clusters are found on both the upstream and downstream sides of the Muralla and are similar in size and composition to the cobbles used in construction of the Muralla. Typically, these features are 1.5 m from the wall and are herein interpreted to have been used as stockpiles for general construction, repairs, or to enlarge the Muralla.

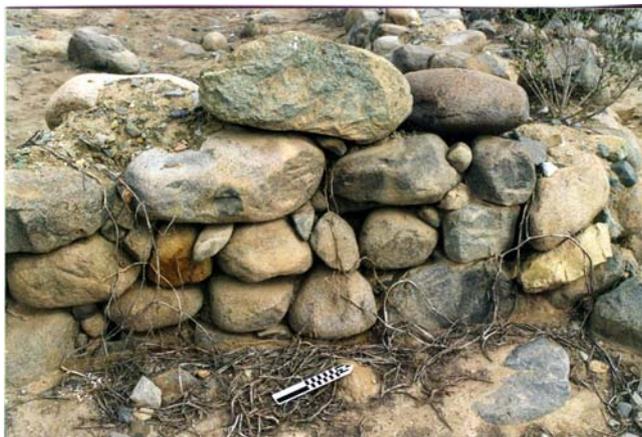
**Fig. 6** Construction of dwelling walls at Santa Rita B, scale is 20 cm

- The construction techniques used for dwellings at Santa Rita B were also labor intensive, purposeful, and selective but contrast with the Muralla construction. Specifically, sub-angular boulders of a variety of sizes (poorly-sorted) were used for dwellings. Construction materials used for domestic use were selectively chosen; however, in contrast, these materials were sub-angular, had to be quarried, and transported from nearby hills across drainages that contained abundant, available, and closer, but rounded, construction materials. And, apparently lesser attention was given to the details of organization (Fig. 6), however, the long axes of the sub-angular boulders are commonly parallel to the wall.

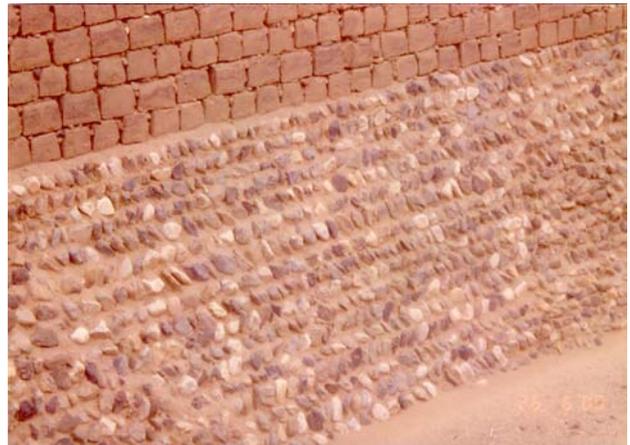
**Fig. 7** Well-rounded, well-sorted, imbricated cobbles used to line the bottom of the reservoir at the Chimú site of Chan Chan, Moche Valley, northern Perú

- Specific construction techniques and materials are related to pre-Columbian water control engineering technology. For example, construction of the base of the reservoir at the Chimú site of Chan Chan (Fig. 7) in the Moche Valley utilized well-sorted, flattened, sub-rounded construction stones (Squier 1877). These were intentionally imbricated, possibly in an attempt to duplicate the natural imbrication and fabric of stones associated with water courses and shingled beaches in the region.

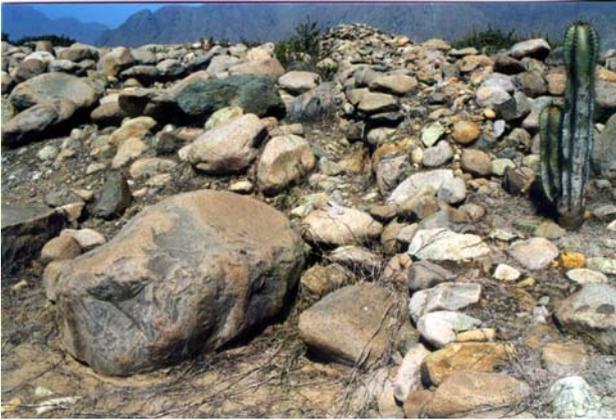
**Fig. 8** Post-Muralla debris flow boulders about the Muralla Pircada, Chao Valley, northern Perú, upstream to the left

- At numerous places along the Muralla, meter-sized or larger, sub-angular boulders are deposited directly against (Fig. 8), but are not included in, the Muralla. It is unlikely that the Muralla would have been built in such close proximity to pre-existing boulders and this “contact” demonstrates torrential deposition of these boulders during post-Muralla debris flows in the Chao Valley.
